BARRICK GOLDEN SUNLIGHT

CASE STUDY

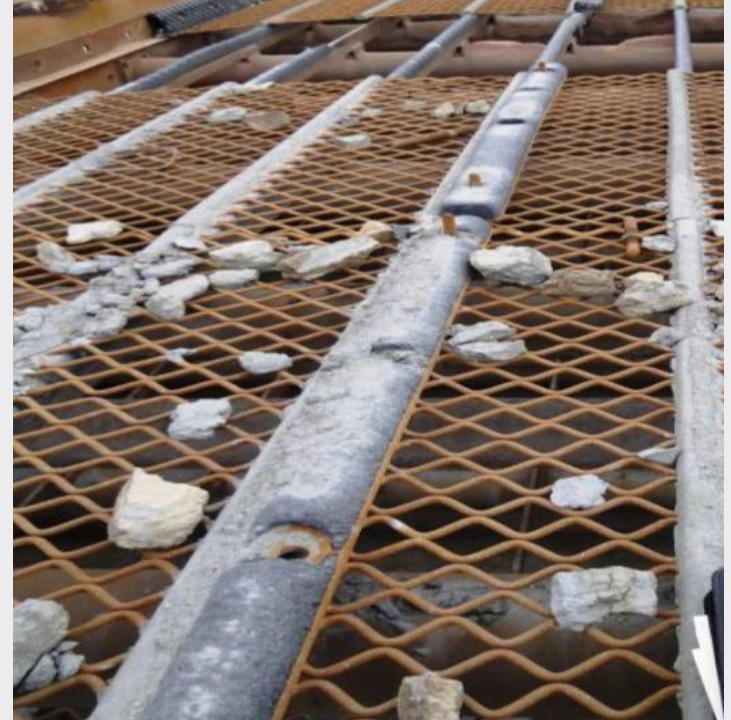
- 3 – 4 week wear life was extremely poor relative to other plants
- Evidence of problems from 'z' wire found on site
- Downtime due to build up, maintenance and wire change-outs was starting to take its toll
- Excessive travel rate

** Image of competitor's 2" wobble wire on top deck of secondary scalping screen*

Polydeck replaced the heavy gauge wire cloth with Rubberdex, allowing for longer wear life than what the operation was experiencing.

Using 40 durometer rubber allowed the operation to run the screen backwards, slowing the travel rate and allowing a more efficient separation.

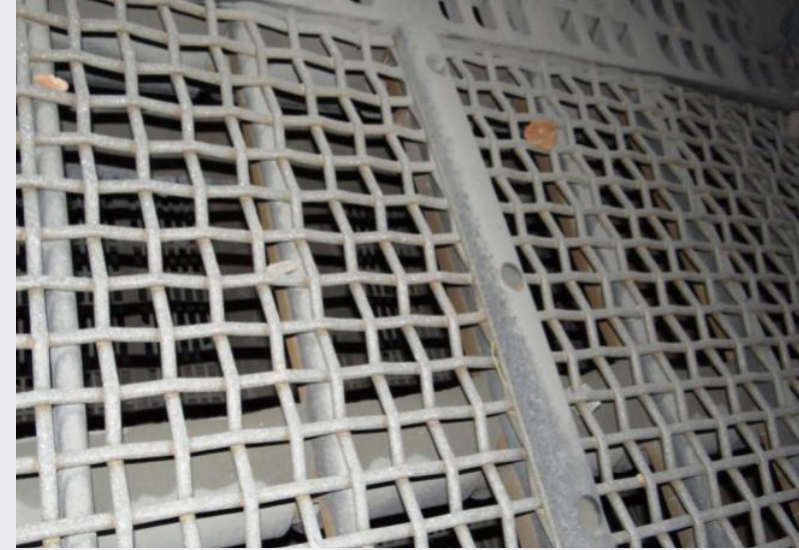
** Image shows competitor wire on bottom deck of screen.*
